**NASA Contractor Report 2943**

**Effects of Service  
Environments on Aluminum-  
Brazed Titanium (ABTi)**

**Boeing Commercial Airplane Company  
Seattle, Washington**

**Prepared for  
Langley Research Center  
under Contract NAS1-13681**

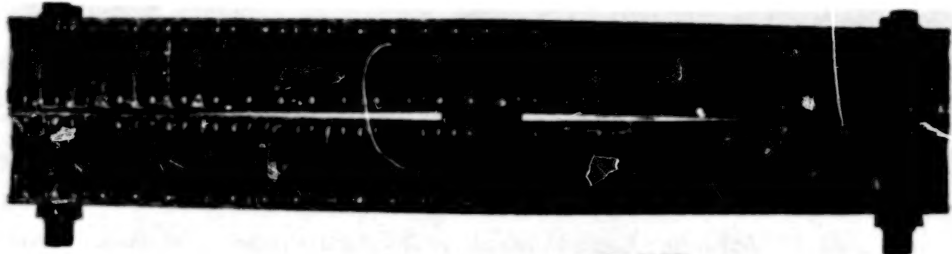
*Figure 4. – 5000 Hours Thermal Exposure in Air*

The 5000-hour thermal exposure in air resulted in an increasing oxide heat tint with temperature, as shown in figure 4. There were no signs of loose scale, structural oxidation damage, or hydrogen pickup.

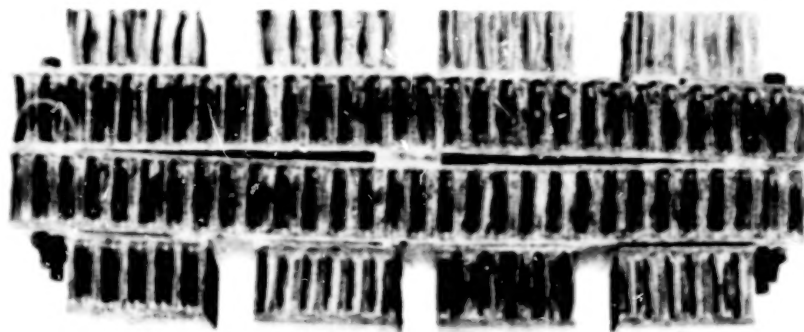
Figure 6. — 5000 Hours Exposure, Synthetic Seawater

Note: After 30 applications

The 5000-hour thermal exposure coupled with periodic applications of synthetic seawater resulted in the buildup of a heavy layer of dried salts. There was a very discernible H<sub>2</sub>S odor during spray application of the seawater to the hot specimens, indicating an appreciable thermal breakdown of the Na<sub>2</sub>SO<sub>4</sub> constituent. There was no evidence of galvanic attack or corrosion pitting of aluminum at any temperature, indicating that the braze alloy is not susceptible to hot-salt corrosion at service temperature and that the 2-hour maximum exposure to aqueous salts during each application was insufficient to initiate the conventional corrosion mechanism.

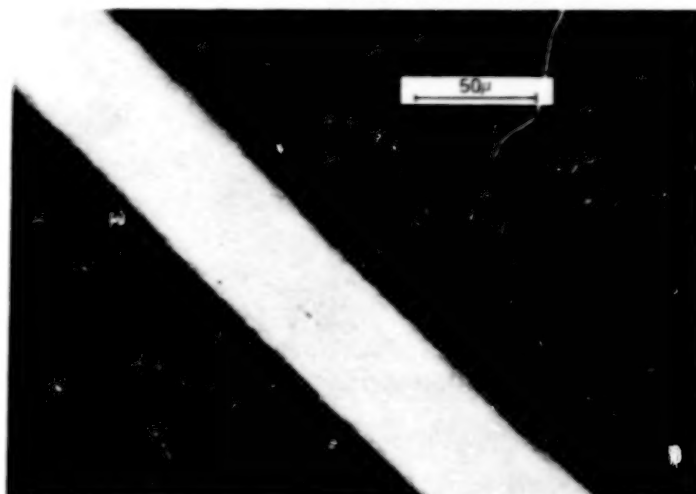
*Figure 8. — Hot Salt Corrosion of Titanium Core*

No attack on  
cell walls

Shallow planar cracks  
in cell walls

Deep pits and cracks  
in cell walls

Exposure to seawater at 700 and 755 K (800° and 900° F) resulted in extensive hydrogen pickup by the titanium core and a significant reduction in flatwise tensile strength, with all failures occurring in the titanium honeycomb core. The loss in flatwise tensile strength proved to be due to hot-salt pitting corrosion of the titanium core (see fig. 8). In the presence of stress, the occurrence frequently included planar cracks perpendicular to the direction of stress. At 755 K (900° F), pitting occurred at bare titanium areas and at the root of cracks through the aluminide layer (fig. 9). Hot-salt corrosion of titanium has been encountered previously, and is accompanied by
